## Analysis of shaft alignment on vibration and motor power consumption in cooling water pumps

# Analysis of shaft alignment on vibration and motor power consumption in cooling water pumps

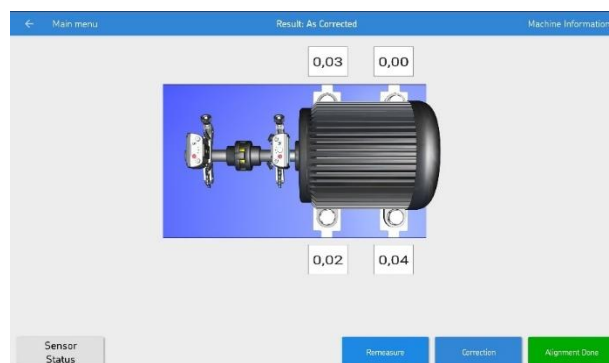
Figure 1. Soft foot inspection results

The results of the soft foot inspection are shown in the figure above, with measurement values around the motor foot points recorded as 0.03 mm, 0.00 mm, 0.02 mm, and 0.04 mm. These values indicate gaps or imbalances at each motor foot, illustrating the amount of correction needed to level the machine. The ideal soft foot value is as close to zero as possible, and the industry standard typically used for raw water pumps is less than 0.05 mm. Although such small soft foot conditions may not cause immediate damage, they can adversely affect the long-term health of the machine, as indicated in Table 1.

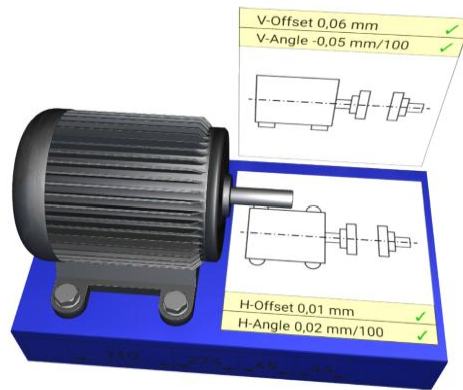
Figure 3. Measurement results after repairs

The shaft alignment measurement was conducted to ensure the conformity of the position and angle between the motor and the components installed in the assembly, as illustrated in Figure 3. The main parameters measured include vertical offset (V-Offset), horizontal offset (H-Offset), as well as vertical angular deviation (V-Angle) and horizontal angular deviation (H-Angle). The measurement results after the alignment correction are shown in Table 4.

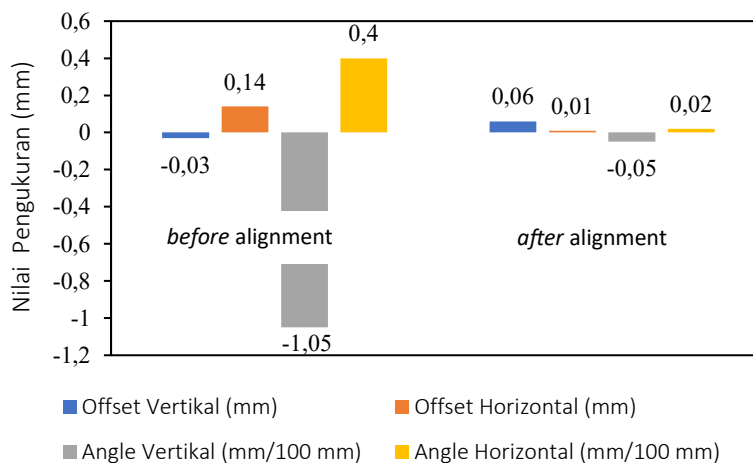
Figure 4. Histogram before and after shaft alignment

The graph above explains the condition of misalignment and the condition after corrective shaft alignment was performed. The measurement values before correction showed considerable variation, especially in the angular error parameters (vertical and horizontal angles) with values of -1.05 mm/100 mm and 0.4 mm/100 mm, respectively, compared to the tolerance value of 0.08 mm/100 mm. After correction, the vertical angle changed by 1 mm to -0.05 mm/100 mm. The horizontal angle decreased by 0.38 mm from 0.4 mm/100 mm to 0.02 mm/100 mm. The relatively flat orange line close to the zero axis

in the graph indicates that the correction successfully stabilized the position and angle of the shaft effectively.

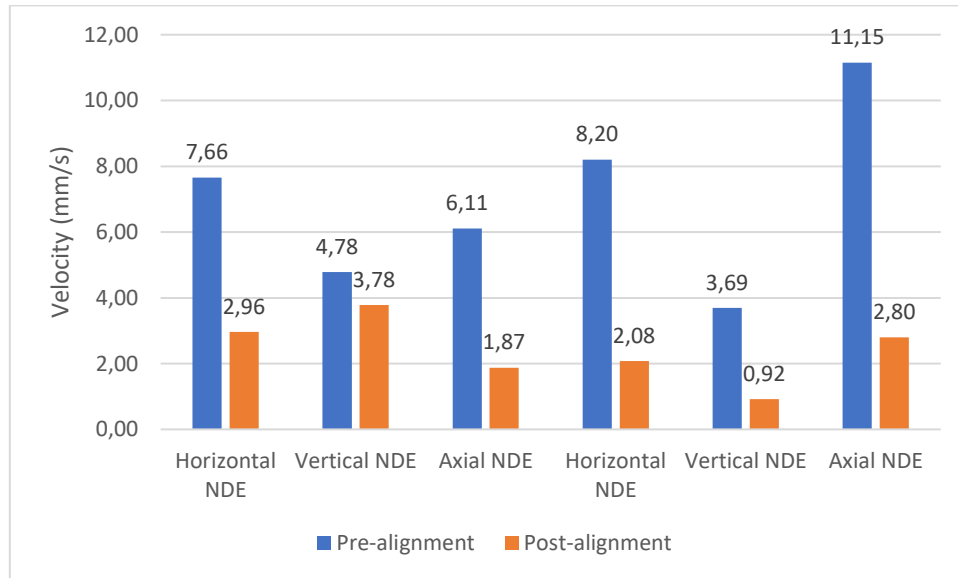
Figure 5. Vibration value graph before and after alignment

The vibration value at the axial DE point before repair was 11.15 mm/s. After the repair was conducted, the vibration value decreased to 2.8 mm/s. On the horizontal DE side, the vibration decreased from 8.20 mm/s before repair to 2.08 mm/s after repair.

Based on the vibration velocity measurement data in Tables 3 and 5 and the graph in Figure 5, all measurement points show a decrease in vibration velocity. The largest decrease in vibration velocity occurred at the Motor Axial DE point with a reduction of 8.35 mm/s, while the smallest decrease was at the Motor Vertical NDE point with a reduction of 1 mm/s after repair.

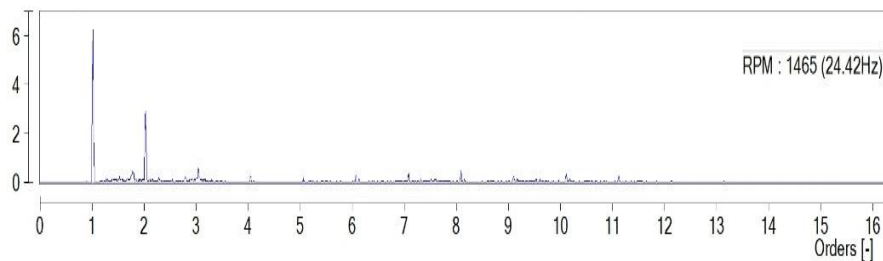
Figure 6. Horizontal DE Motor Vibration Spectrum

In the horizontal spectrum, in Figure 6, strong amplitudes at the 1 $\times$  and 2 $\times$  running frequencies reflect coupling forces induced by misalignment. The vertical spectrum, in Figure 7, shows similar harmonic components but with lower amplitude compared to the horizontal direction, suggesting uneven load distribution across the motor bearings. The

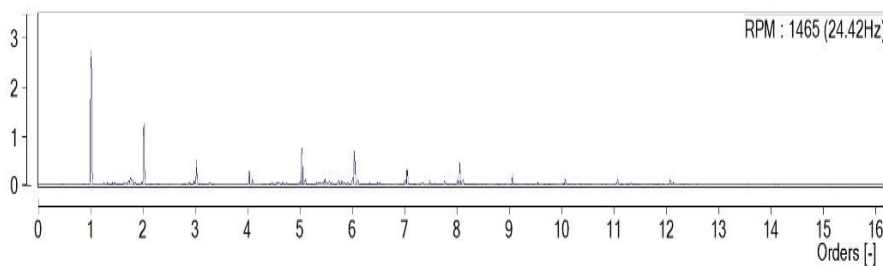
Figure 7. Vertical DE Motor Vibration Spectrum

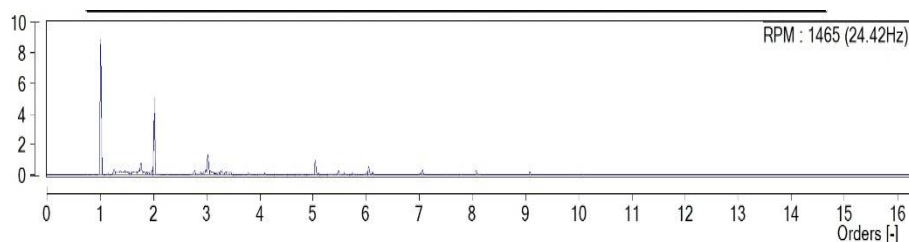
Figure 8. Axial DE Motor Vibration Spectrum

axial spectrum, in Figure 8, exhibits the highest amplitudes. It reaches nearly 10 mm/s, which is a distinct signature of angular misalignment. High axial vibration is widely recognized in the literature as a primary symptom of shafts not being collinear. The reduction in power consumption, as calculated in Table 7, decreased from 44.3 kW to 40.6 kW after alignment using Equation (1), resulting in a value of 8.35% as follows:
