**"THERMAL EFFICIENCY ANALYSIS OF COMBUSTION TURBINE GENERATOR (821-G-101) PT TRANS PACIFIC PETROCHEMICAL INDOTAMA AFTER MAJOR INSPECTION "**

**Rekayasa Mesin**, Vol. 15 No.3 (2024), Halaman 1405-1415, 15 Desember 2024

# THERMAL EFFICIENCY ANALYSIS OF COMBUSTION TURBINE GENERATOR (821-G-101) PT TRANS PACIFIC PETROCHEMICAL INDOTAMA AFTER MAJOR INSPECTION

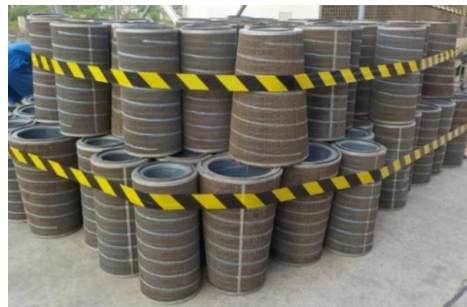
**Figure 9.** IAF conditions before MI CTG 101

#### a. Replacement of Air Inlet Filter

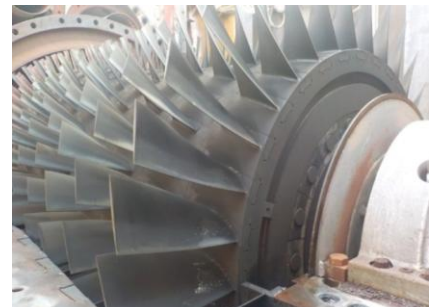
**Figure 10.** Fouling conditions on the Compressor Rotor Blade before MI CTG 101

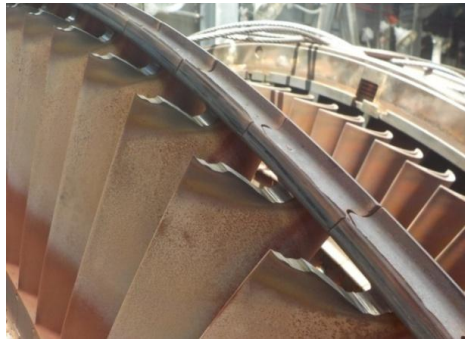
The stage 2 bucket turbine of **Figure 11** was found to have suffered severe damage during major inspection. Damage to the stage 2 turbine bucket is caused by friction (rubbing) with the seal plate on the exhaust plenum that is damaged first. Damage to the stage 2 turbine bucket is at the end of the bucket (blade tip) with a damage area of about 5-10%. This results in a decrease in the cross-sectional area of the bucket, so that the kinetic energy of the hot gas rate cannot be converted optimally to rotate the turbine [5,15].

**Figure 11.** Turbine Stage 2 Bucket Damage before MI CTG 101

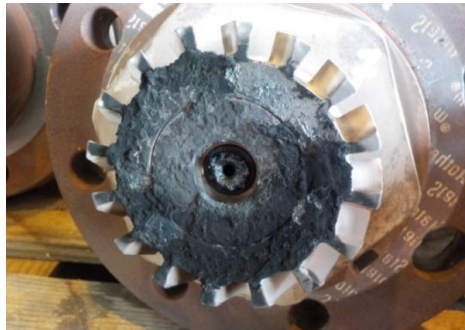
Replacement of parts in the fuel system of **Figure 13** includes replacement of fuel nozzle, fuel check valve and flow divider. During a major inspection, damage to the fuel nozzle was found, namely wear on the swirl tip plate and nozzle tip. Damage to the tip nozzle results in an incomplete atomization process between liquid fuel (kerosene) and atomizing air, resulting in a less complete combustion process. One indicator of complete and flat combustion in gas turbines is a flat turbine exit temperature or low exhaust temperature spread [5,15].

**Figure 13.** Fouling Conditions on the Fuel Nozzle Before MI CTG 101

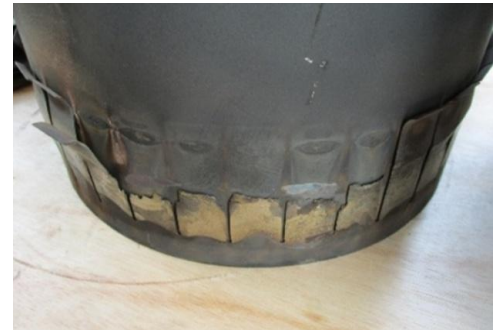
Replacement parts in the combustion chamber of **Figure 14** include combustion liner, transition piece, crossfire tube. During a major inspection, damage to the combustion liner was found, namely wear on the hula seal. Damage to the hula seal results in hot gas losses due to a sealing system that is not optimal, thus resulting in the flow rate of hot gas from the combustion chamber to the turbine will be reduced due to internal recirculation of the combustion product to the dilution gap of water and cooling water [5,15].

**Figure 14.** Hula Seal Damage to Combustion Liner Before MI CTG 101

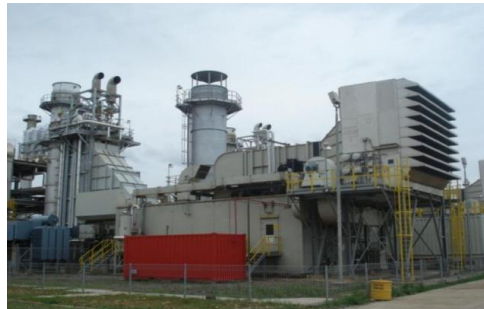
**Figure 1.** Unit CTG 101 at PT TPPI

| Combustor | : 10 units, annular and dual fuel type, max temp. Spark plug 2 unit, flame scanner |
| Fuel nozzle | : one per combustor, mix fuel |

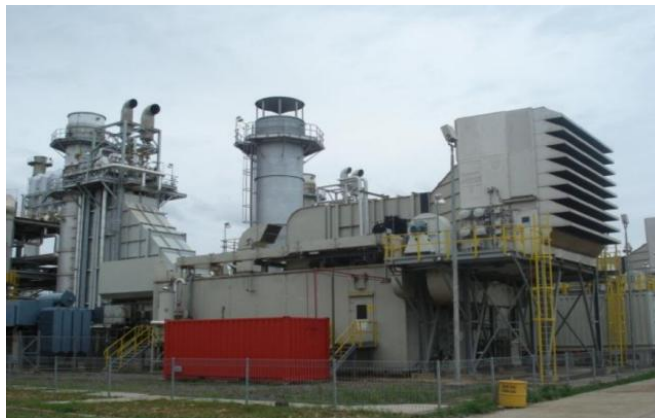
**Figure 1.** Unit CTG 101 at PT TPPI

| Combustor | : 10 units, annular and dual fuel type, max temp. Spark plug 2 unit, flame scanner |
| Fuel nozzle | : one per combustor, mix fuel |

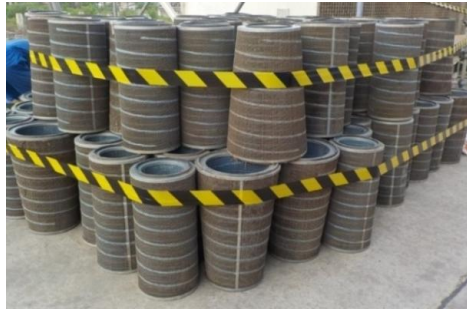
**Figure 9.** IAF conditions before MI CTG 101

a. Replacement of Air Inlet Filter

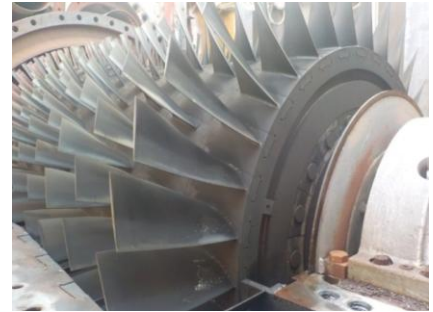
**Figure 10.** Fouling conditions on the Compressor Rotor Blade before MI CTG 101

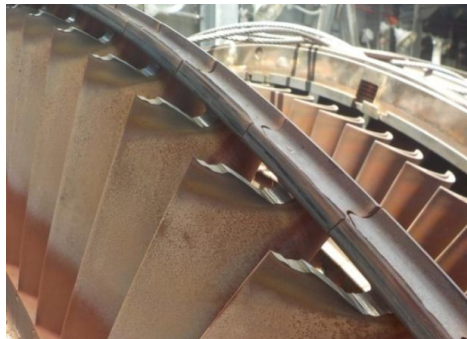
The stage 2 bucket turbine of **Figure 11** was found to have suffered severe damage during major inspection. Damage to the stage 2 turbine bucket is caused by friction (rubbing) with the seal plate on the exhaust plenum that is damaged first. Damage to the stage 2 turbine bucket is at the end of the bucket (blade tip) with a damage area of about 5-10%. This results in a decrease in the cross-sectional area of the bucket, so that the kinetic energy of the hot gas rate cannot be converted optimally to rotate the turbine [5,15].

**Figure 11.** Turbine Stage 2 Bucket Damage before MI CTG 101

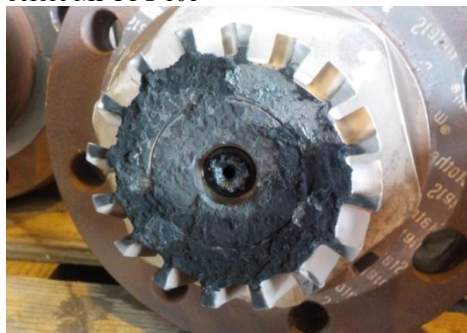
Replacement of parts in the fuel system of **Figure 13** includes replacement of fuel nozzle, fuel check valve and flow divider. During a major inspection, damage to the fuel nozzle was found, namely wear on the swirl tip plate and nozzle tip. Damage to the tip nozzle results in an incomplete atomization process between liquid fuel (kerosene) and atomizing air, resulting in a less complete combustion process. One indicator of complete and flat combustion in gas turbines is a flat turbine exit temperature or low exhaust temperature spread [5,15].

**Figure 13.** Fouling Conditions on the Fuel Nozzle Before MI CTG 101

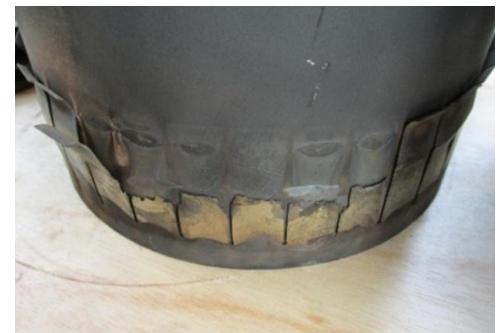
Replacement parts in the combustion chamber of **Figure 14** include combustion liner, transition piece, crossfire tube. During a major inspection, damage to the combustion liner was found, namely wear on the hula seal. Damage to the hula seal results in hot gas losses due to a sealing system that is not optimal, thus resulting in the flow rate of hot gas from the combustion chamber to the turbine will be reduced due to internal recirculation of the combustion product to the dilution gap of water and cooling water [5,15].

**Figure 14.** Hula Seal Damage to Combustion Liner Before MI CTG 101
